Autopsy on an RF-Processed X-band Travelling Wave Structure

F. Le Pimpec, S. Harvey, R.E. Kirby, F. Marcelja

**Stanford Linear Accelerator Center
2575 Sand Hill Road
Menlo Park, CA 94025 USA**

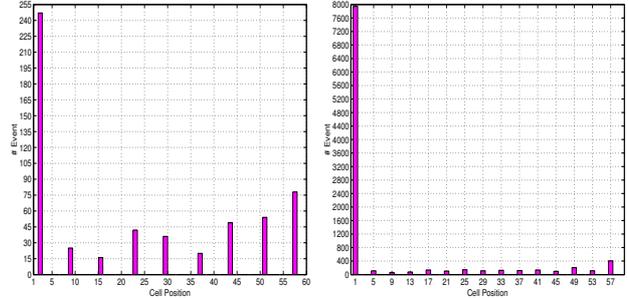
Figure 2: Example of damage localization in T53Vg3R (left) - T53Vg3RA (right) during operation

The breakdown pattern localization Fig.2 reveals that most of the breakdown are occurring in the input coupler (IC) of the TW. In Fig.3 we can see that the input coupler is divided into two parts the waveguide section, left side of the picture and the cell side in the center. The feature separating the waveguide side and the cell side is denominated "horns". The gap between the top and bottom horn is ~ 9 mm.

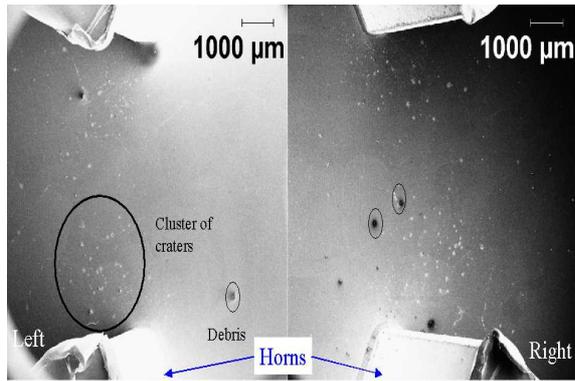
Fig.4, 5 and 6 reveal a very interesting pattern of damage. The craters on the floor of the IC, Fig.4, are mainly located along the imaginary circles connecting the two faces of the horns. Closing up to the horns and focusing on the

Figure 4: Pitting due to RF breakdown on the floor of the Input coupler. The iris is in between the horns.

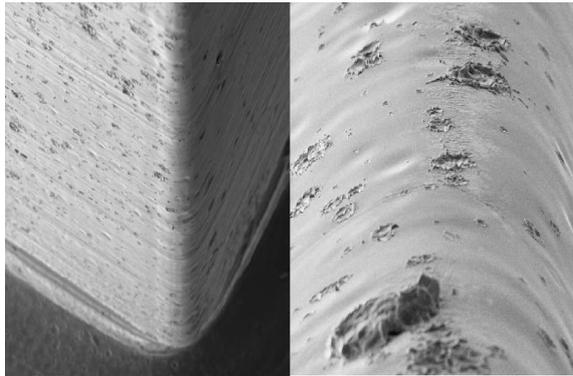
details, one can observe droplets of copper [3]. Craters appears on all the sides of the horns, with a density higher in the face side than the waveguide or cavity side. Looking more closely of the edges of the four horns has revealed that the edge on the waveguide side, Fig.5, shows little damage. In the contrary the edge on the cell side shows a chaos of features, Fig. 6, with sharp and melted objects. The dimension bar in the right picture of Fig.6 is $\sim 10\mu\text{m}$.

Figure 5: Typical damage on the waveguide side of a horn of the IC

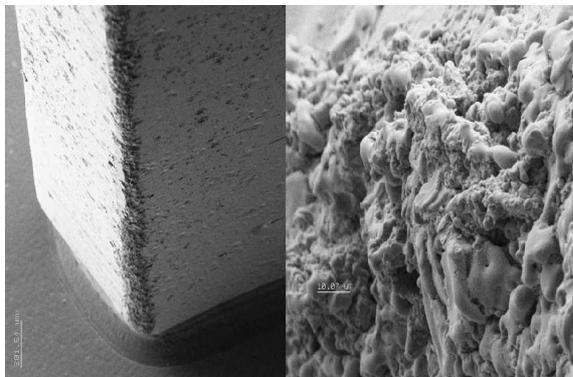
Figure 6: Typical damage on the Cell side of a horn of the IC

be invoked to explain the damages. However, the horns lies in a very low electric field area, and the vacuum is of the order of 3.10^{-9} Torr. It is then not possible to explain how such a low gas density and kinetic energy might start a breakdown leading to the so seen damages. It is also not possible to explain the very localization on the edge of the cavity side of the horns Fig.6. During processing, the RF pulse went from 50 ns to 400 ns carrying up to 100 MW of power. Part of this energy is dumped in the Cu in form of heat or directly or by the induced current due to the high magnetic field 0.7 MA/m at 400 ns pulse length [5]. Along the edge ($76\mu\text{m}$ radius) this RF pulse heating leads to an increase of temperature up to $130\text{ }^\circ\text{C}$. It is clear that this temperature do not cause the observed damage. However, it might induce thermal fatigue in the Cu, inducing formations of cracks, as observed in [6], and leading in roughening of the edge. As the surface becomes rougher, the local resistivity of the Cu increases leading to a higher temperature maybe up to the melting point ($1083\text{ }^\circ\text{C}$). At this temperature, the vapor pressure of the Cu is $\sim 3.10^{-4}$ Torr [7]. This gas can now be ionized by the electrons coming form the surface and back bombard the horns. As a result, raising up the temperature and sputtering the surface. We might, in addition, explain the droplet of Cu seen at the surface of the floor. The patterns of craters on the floor, Fig.4, seems to follow the high magnetic field line. As we move toward the center the density of craters diminish and increase again as the electric field start to be consequent Fig 7.

Following our autopsy many studies and simulation led to the decision of rounding the edge to 3mm instead of 76 μm radius in order to avoid the thermal fatigue roughening mechanism. It is believed that the new design of the IC and OC implementing this rounding will cure our breakdown problem in those couplers. Also, machining a 3mm edge radius should leave the surface extremely smooth. We have shown on an identical input coupler of T53Vg3R, Fig.9, that the 4 edges of the cavity side of the horns present a roughness after machining. Following the etching and thermal processing, that sees the structure, do not removed this roughness. In a contrary, the edge on the waveguide side of the horns are well finished.

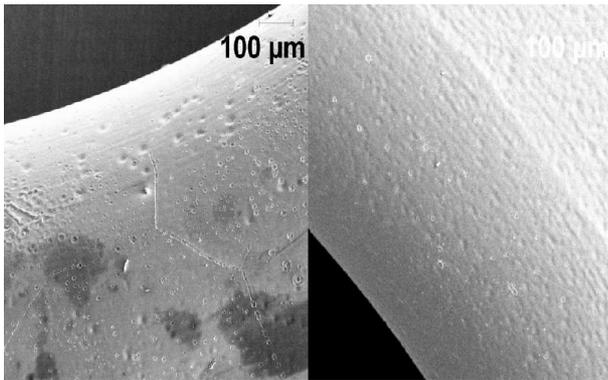
SEM (secondary electron microscopy) Fig. 7 shows the damage on the upstream side and the downstream side of the iris, respectif to the displacement of the NLCTA electron beam. On both sides etch pits can be seen as well as craters. However, the density of craters is much higher in the upstream side. Many craters are also located in the grain boundary. A particle search in and out of the craters shows MnS located in and out of them. Most of this inclusions are located in the grain boundary. The analysis of the contents of the craters shows mainly pure Cu. The black spots on the upstream side is carbon. An Auger analysis of the surface, not including those spots, shows heavy contamination by carbon of this iris [3]. Carbon contamination due to electron bombardement is a well known problem, [8]. There is no such contamination in iris 28 further down the structure [3].

Figure 7: Activity on the 1st iris, Upstream side left picture and downstream side right picture

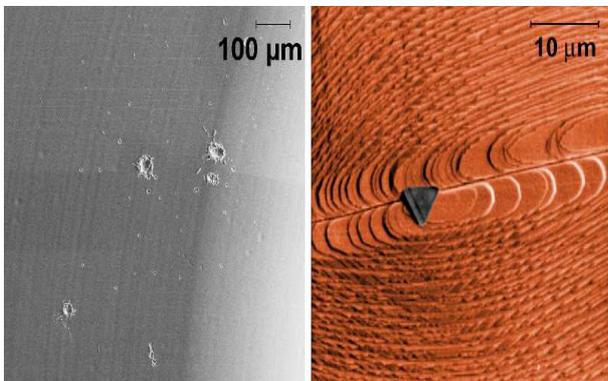
As we move toward the output coupler (OC), the activity on the irises decreases, endoscope (boroscope) monitoring. Fig.8 shows the sparse activity on the 28th iris of the structure. As we looked for particles/inclusions on the surface and at the grain boundary, we did not find MnS. However, some other sulfur compound were found [3], as the atypical one shown in Fig.8.

The cells used to make the structure are bonded and then brazed in a stainless steel (SS) H_2 furnace at $\sim 1020\text{ }^\circ\text{C}$. The Sulfur (S) composition is 0.03 weight % in stainless steel. Other material like Mn, Cr, Ni are also used in the making of SS. The solubility of sulfur in copper is

Figure 8: Activity on the 28th iris, Upstream side. CrS inclusion at a twin boundary, right picture

very high at this temperature and significant at a few hundred °C. Hence, a significant amount of S can get into the copper. After its fabrication, the structure is vacuum baked in a SS pot at 650°C for few days, in order to desorb the H₂. Metals might be present in the atmosphere of the H₂ furnaces and bakeout pot at this given temperature, with vapor pressures of 10⁻⁵ Torr for Mn, 10⁻¹¹ Torr for Cr, 10⁻¹ Torr for Ca and below 10⁻¹¹ Torr for Ni [7]. At 300°C and above the S concentrates at the grain boundaries of the Cu. The S also start migrating to the surface at low temperature 75°C [9]. The Model for sulfur compound formation is that the sulfur getters the metal vapor out of the furnace atmosphere to form crystals/inclusions at/near the grain boundaries. A particle search on the IC reveals that ~80% of the particles are Mn-S. On the very next iris the proportion falls to ~50%. The search in the 28th cell shows no Mn-S but S-compounds are present at ~50%. Finally the search on the last cell in front of the OC shows Mn-S and other S-compounds. Finally in all the cases, other particles are compounds based on C, Al and Si not excluding the presence of Mn or S or other elements. This model might explain the sulfur compound formation, but the understanding of the distribution along the structure of those elements is under investigation.

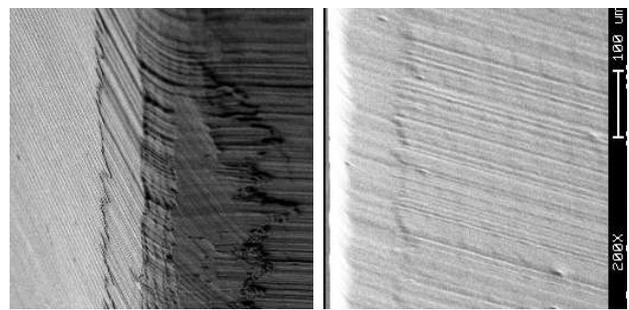
Figure 9: Surface of the edge, cell side, of a horn after machining (left) and after 60" etch and thermal processing
