## SEM Examination of a Newly-Machined NLCTA Cell<sup>†</sup>

R. E. KIRBY AND C. PEARSON, *Stanford Linear Accelerator Center  
Stanford University, Stanford, CA 94309*

*An as-received not-SLAC-cleaned cell was examined in the SEM. A number of native and machining defects were visible.*

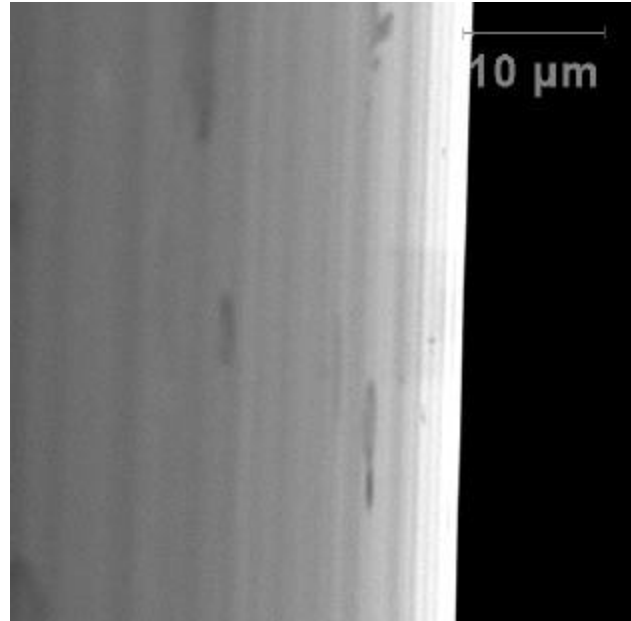
Figure 1 shows the cell surface at the iris ID. Residual lubricant is visible in the form of black streaks. However, the machining structure is uniform with no burrs visible at the iris. That was also true when examining the rest of the iris ID. The lubricant would normally be removed by the cleaning process for cells, SLAC Plating Shop Process C01a. Only machining ridges would remain after cleaning, without significantly roughening the surface finish.

Figure 1. Cell surface near iris ID. Except for machining ridges, all other features should be removed in the C01a cleaning process.

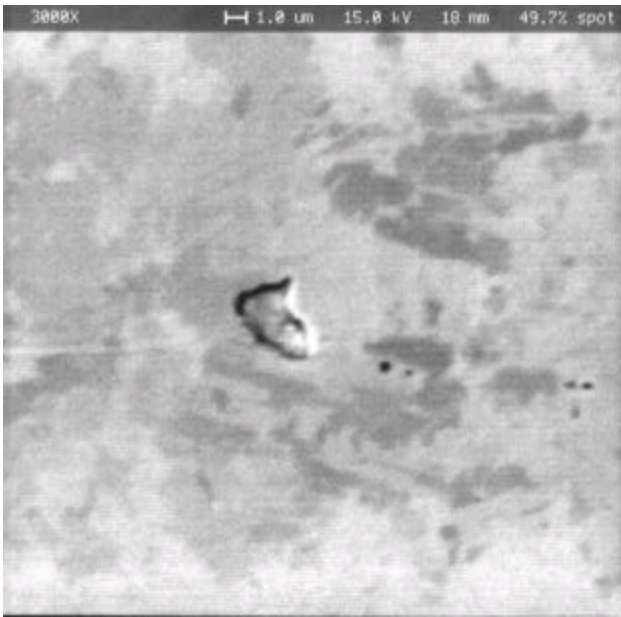
Figure 2. Missing copper grain and inclusions. Mottling is probably due to traces of cutting fluid on the surface.

The central large feature is a missing copper grain. It is identified as sub-surface by using a special SEM technique, electron backscatter imaging. The view generated by this technique is equivalent to placing light illumination at 10 o'clock. The edge shadow observable identifies the feature as sub-surface. In this case, the grain was improperly consolidated with its neighbors and either fell out or, more likely, was knocked out by passage of the cutting tool.

Also visible in the same image is a string of holes (or carbon inclusions) to the right of the missing grain. This is a native feature found, at very low density, in the best quality copper.

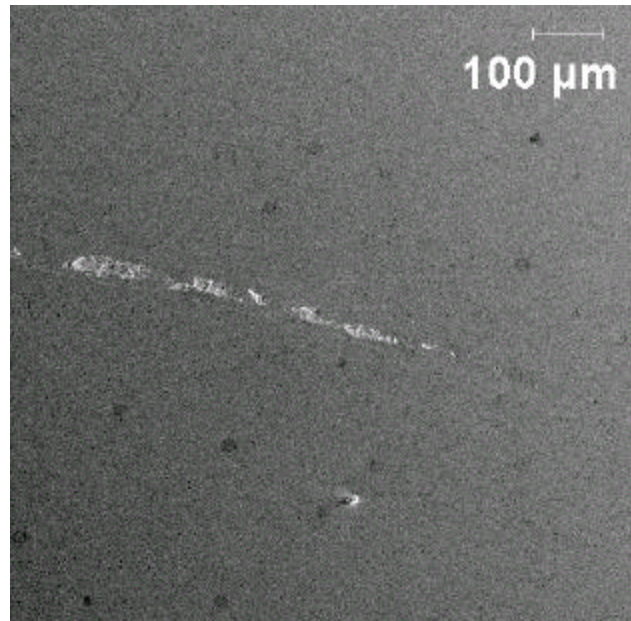
This cell also exhibited the long machining feature which is the focus of this report, shown in Figures 3-5. Figure 3 is an overall low-magnification image. Figures 4 and 5 show detail of the two ends of the feature. Figure 4 is particularly interesting because it shows the fracturing of material at the starting end of the feature. What is not visible, because of the contamination film, is the grain structure of the surface. In earlier work on clean hydrogen-fired cells, we observed that such leading edge tearout begin at a grain edge. Porosity at the grain boundary, or perhaps elsewhere in the grain, coupled with favorable cutting parameters, tool geometry and crystal orientation results in shearing just below the cutting plain. Galling and tearing occur between tool and grain, which eventually clears the tool.

Figure 3. Machining tearout. Black spots are likely cutting fluid droplets.

The tearout imaged in Figures 3-5 cannot be removed by mild etching. Heavy etching, on the other hand, will roughen the surface. Features of this type may possibly be minimized by changing cutting tool parameters or feed rates.

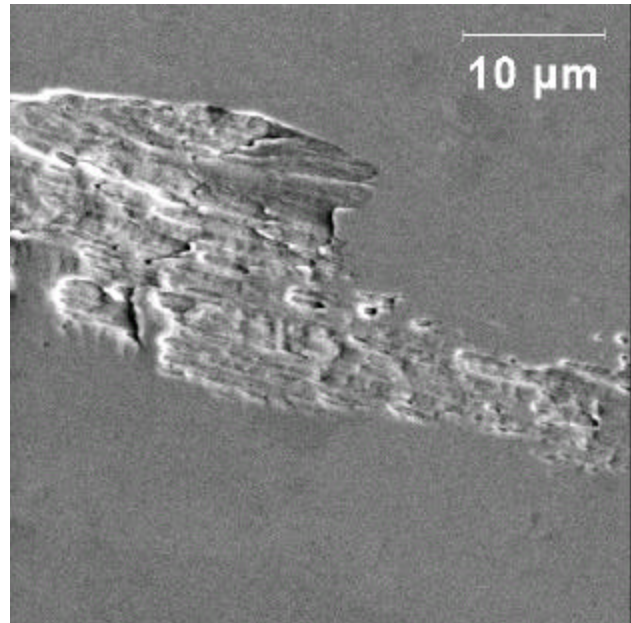
Figure 4. Enlarged image of clockwise (believed to be leading edge) of tearout. Note the fracture of material at the upper center of the image.

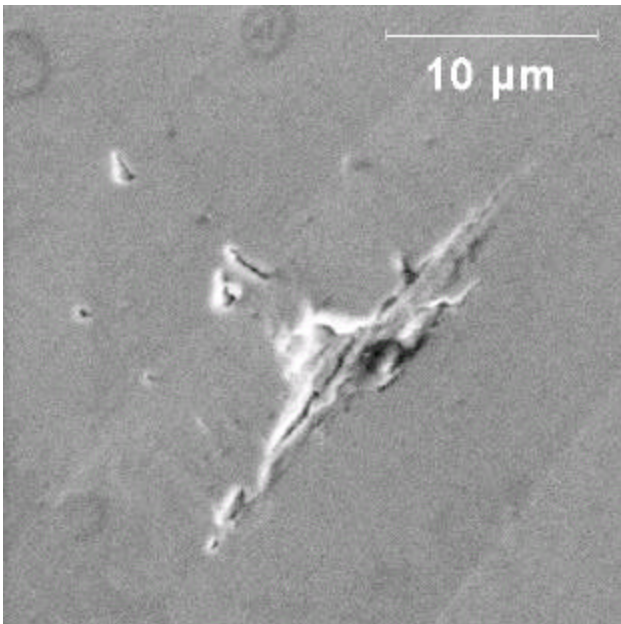
Figure 5. Counter-clockwise end of the tearout. Note the wide (relatively!) diagonal machining ridge.
