Autopsy on an RF-Processed X-band Travelling Wave Structure

F. Le Pimpec, S. Harvey, R.E. Kirby, F. Marcelja

**Stanford Linear Accelerator Center
2575 Sand Hill Road
Menlo Park, CA 94025 USA**

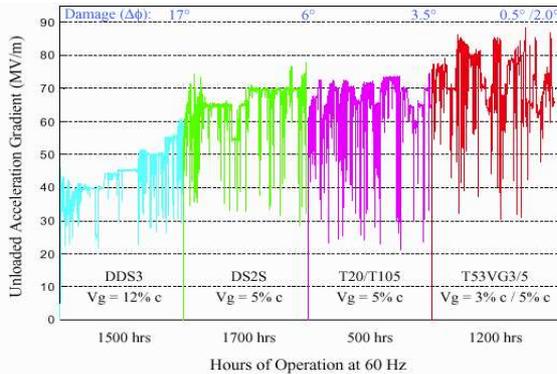
Figure 1: History operation at NLCTA of some 11.424 GHz TW structures, ©Adolphsen

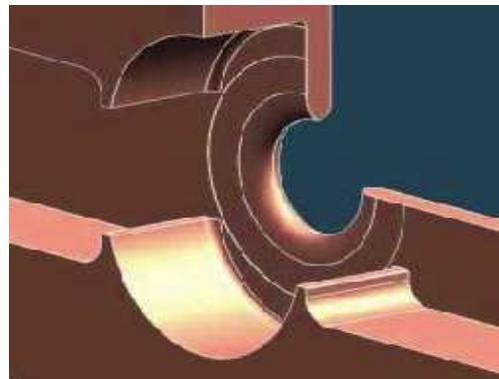
The breakdown pattern localization Fig.2 reveals that most of the breakdown are occurring in the input coupler (IC) of the TW. In Fig.3 we can see that the input coupler is divided into two parts the waveguide section, left side of the picture and the cell side in the center. The feature separating the waveguide side and the cell side is denominated "horns". The gap between the top and bottom horn is ~ 9 mm.

Figure 3: Input coupler design. The center is the cavity side with the first iris
