EFFECT OF OZONIZED WATER TREATMENT ON ELECTRICAL BREAKDOWN OF OXYGEN-FREE COPPER ELECTRODES OF A VACUUM GAP

S. Kobayashi*, K. Sekikawa*, K. Ohira*, K. Asano** and Y. Saito**

Abstract - A recently developed ozonized water treatment technique was applied to surface treatment of oxygen-free copper electrodes. Breakdown characteristics of the electrodes were measured in a vacuum by applying impulse voltages. Results showed that the breakdown field at the first voltage application was not improved, but the conditioning effect of the gap by repetitive breakdowns was significant. The value of breakdown field after conditioning was around 250 MV/m (for a 0.3-mm gap length). Breakdown fields were lowered to values similar to those of the first voltage application, after the conditioned electrodes were exposed to air for two to three weeks. Reconditioning, however, was achieved rapidly.

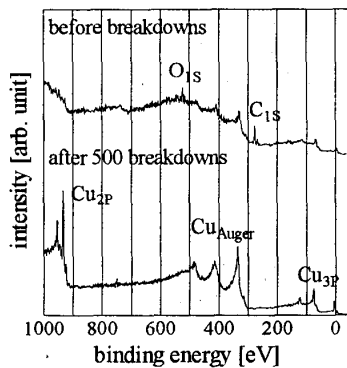
Figure 4 shows XPS wide-scan spectra of the cathode of A_2 electrode before and after 500 breakdowns. The spectra before breakdowns had clear peaks due to oxygen (O_{1s}) and carbon (C_{1s}), and the spectra of Cu_{2p} , Cu_{Auger} and Cu_{3p} are scarcely observed. Therefore, the electrode surface was covered with oxidized film and organic contaminants. The intensities of oxygen spectra were higher than those obtained in our past results. No carbon spectra were expected to be observed, because the electrode was treated with ozonized water. Carbon spectra, however, are clearly observed. After 500 breakdowns, the oxygen and carbon spectra due to contaminants on the electrode surface were removed completely, and the copper spectra clearly appeared. Therefore, the repetitive breakdown process was able to completely clean the electrode surfaces.

Fig. 4. XPS wide-scan spectra of the cathode of A_2 before and after 500 breakdowns.

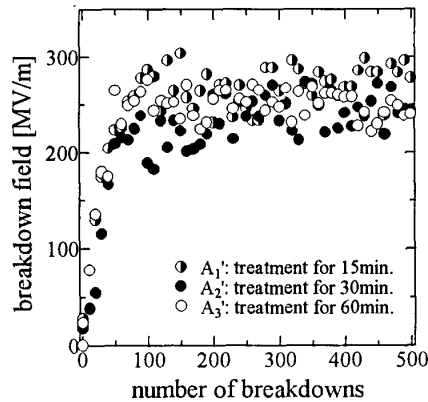
The breakdown fields of conditioned electrodes after exposure to air for two to three weeks are shown in Fig. 5. The electrodes were kept in the

desiccator (20 °C, humidity: 25%) after being subjected to 500 breakdowns (Fig. 3). Ozonized water treatment was done on the A_1 , A_2 and A_3 electrodes for 15, 30 and 60 minutes, respectively. These results demonstrate that exposing the surface to air after 500 breakdowns (conditioned) lowers the breakdown strength and the reconditioning of breakdown fields can be easily achieved. The average electric field after saturation of the breakdown field (about 90 breakdowns) was: 239 MV/m for electrode A_1 , 270 MV/m for A_2 , and 250 MV/m for A_3 , and the first breakdown fields were lower than those shown in Fig. 3.

Fig. 5. Breakdown characteristics of conditioned electrodes after exposure to air.
